Manhole Inspection Summary

Manhole # S43UU_011MH

Insp Date: **2/9/07 10:24 AM**

Location Address: **2826 THE ALAMEDA**

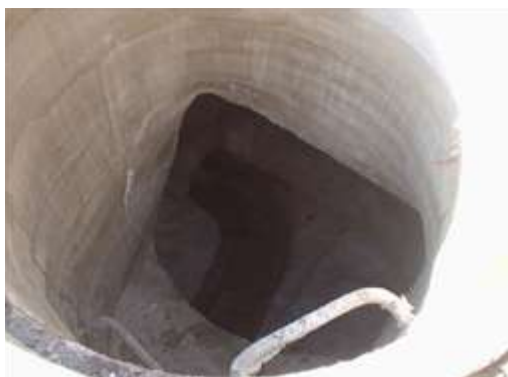
Defect

Infiltration: ☐ None ☒ **Joint** ☐ Cracks ☐ Mortar ☐ Roots ☒ **Wall**

Corbel infiltration.

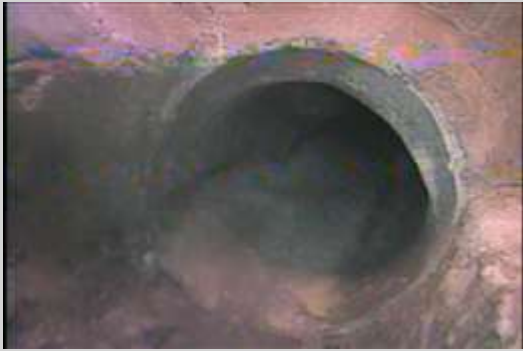
10 in. Circular Gravity Sewer Pipe Out @ 12 O'Clock

Invert Depth: **7.26** (ft.) Flow Characteristics: **Slow**

Infiltration: **Evidence** Pipe Seal Cond: **Unknown**

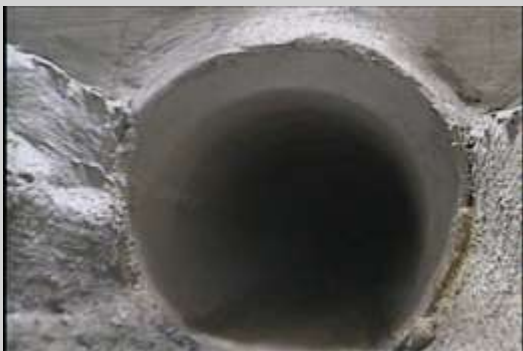
10 in. Circular Gravity Sewer Pipe In @ 9 O'Clock

Invert Depth: **6.93** (ft.) Flow Characteristics: **Slow**

Infiltration: **None** Pipe Seal Cond: **Unknown**
